Building Energy Assessment

*SAU 80 – Shaker Regional School District
Administrative Building*

Energy Audit Report

February 2010

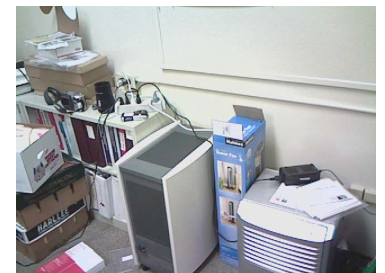
Appliances should be converted to Energy Star rated appliances when new ones are purchased. Furthermore, it is good practice not to allow individual coffee pots and other appliances in offices. Although one personal appliance may not consume much energy, having an appliance at each desk or in each room can usually cost \$10-30 per year, per appliance. Making use of a common kitchen area will cut down on the number of personal appliances and reduce unnecessary spending.

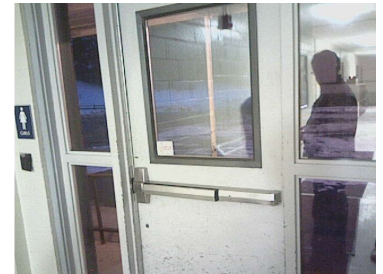
There are a total of five exterior doors on this building. Four are ½ glass, metal insulated doors. The one in the main hallway should be replaced, the other three are in good condition. The last door is a metal, un-insulated door which leads into the boiler room. All doors need new weather-stripping.

ECM 9 – Replacement of exterior doors – Two of the exterior doors were recognized as being in poor condition and should be replaced. Upgrading these doors to insulated ones will reduce the heat loss due to loose door fittings and lack of insulation. The cost for the door project is estimated at \$2,200 with an annual savings of \$150, and paying back in 14.7 years.

ECM 10 – Door seals – We recommend replacing door weather-stripping and seals on a yearly basis, or at least as needed. New caulking and weather-stripping will reduce air infiltration and exfiltration, thus reducing energy spending. For this project, we estimate an expenditure of \$500 will save \$200 annually and payback in 2.5 years.

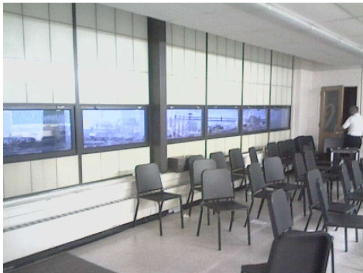
There are a total of ninety-nine windows in this facility. Five windows are double-pane, metal framed, hopper style windows, four windows are double-pane, metal framed fixed windows, and there are forty-five double-pane, metal framed operable windows. All of them should be replaced. They do not have thermal breaks in the frames to keep the cold out and the glass is not a good quality window with good insulating values.

There are forty-five sections of Kal-wal blocks throughout the building. Each section is 26 square feet. Kal-wal in the days of cheap oil was popular. But today they are not good insulators. We are recommending that the Kal-wal be replaced.

ECM 11 – Replace Kal-wal – At the time that this building was erected, Kal-wal was a popular design that allowed in more light throughout a building. However, now that fuel is more expensive, the Kal-wal systems have become a huge reason for loss of heat. All of the Kal-wal sections in the building should be replaced with newer, more efficient windows and wall sections. Although the payback for this project is long, the comfort level of the occupants due to this replacement will be recognized immediately. For this project, we estimate a total expenditure of \$38,000 with an annual savings of \$1,000. This project should payback in 38 years.

ECM 12 – Replace windows – The windows in the building are all outdated and inefficient. We are recommending replacing all of them in order to reduce air infiltration and exfiltration. This project will have an estimated cost of \$21,600, for an annual savings of \$1,000. Although the payback is 21.6 years, occupant comfort will be realized immediately upon replacement.

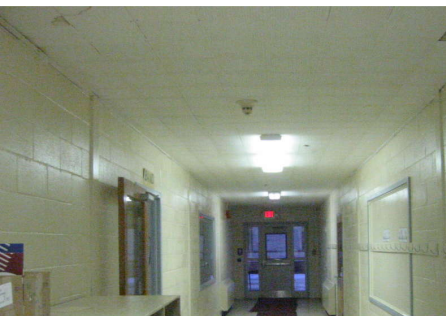
There are one hundred, sixty-five light fixtures in this building. Most are T12 fixtures and should be upgraded to more efficient high-performance T8 light fixtures. The building does have twenty-nine existing T8 light fixtures, two CFL bulbs, and twelve LED exit signs.

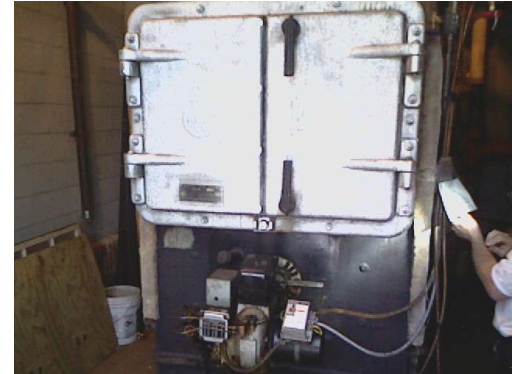
There is a National Steel hot water boiler, model number AC-4275, which was installed in 1950. It is rated at 1,610 pounds per hour or 1,932,000 BTUs per hour. There is also a Carlin burner, model 800CRD with a firing capacity of 11.4 to 19.8 gallons per hour. It was originally a steam boiler but has been converted to produce hot water. It is not efficient due to the conversion and overall size and mass to heat up before being able to supply heat to the building. It should be replaced. There are also two 2-zone circulator pumps.

ECM 7 – Replace boiler – The existing boiler is 60 years old and far beyond its expected life. It should be replaced very soon in order to continue with a reliable heat source. As one option to remedy this issue, we are recommending replacing the boiler with a new one at an approximate cost of \$53,000. The savings will be around \$1,500 annually, for a payback of 35.3 years.

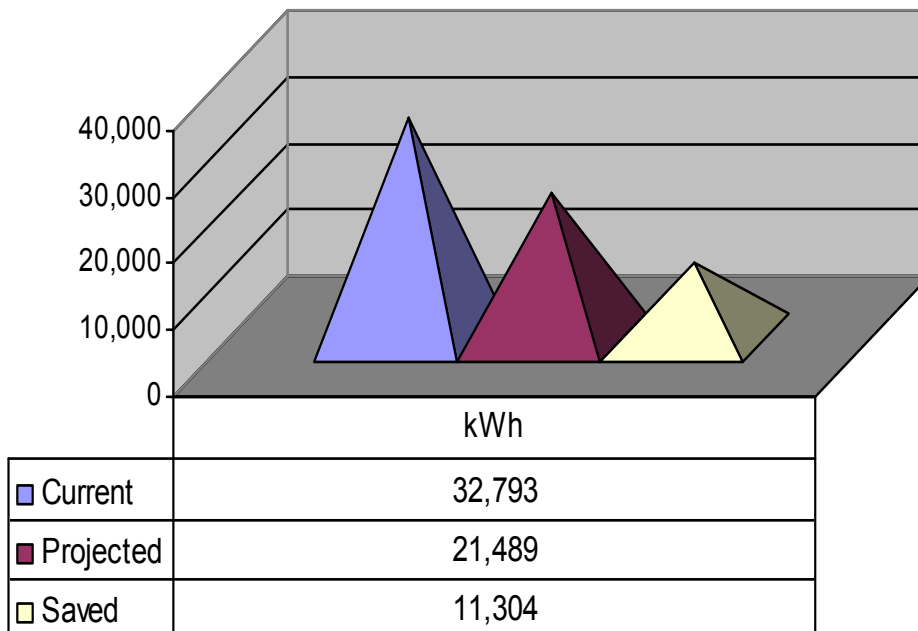
KW Hours Saved - Memorial Administrative Building

Information has been included as part of this report to breakdown light savings calculations by room. The following chart is a summary of the findings and displays the current estimated kilowatt hour (kWh) usage from the lighting only. Based on our recommendations for lighting upgrades, the following projected kWh usage is foreseen, along with the total kWh savings.

*kWh Saved = 11,304
 Lighting Only*

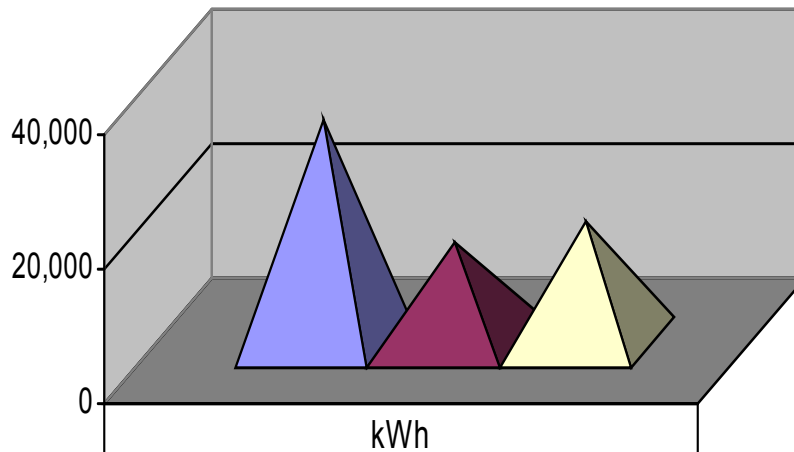
KW Hours Saved - Memorial Administrative Building

The following chart displays current usage and projections if both the lighting and lighting controls are implemented.

Lighting & Controls

**Assumes upgrades to lighting have already been implemented*

■ Current	32,793
■ Projected	14,891
■ Saved	17,902
