*Belmont Middle School*

# ***Energy Audit Report***

**SAU 80 Belmont Middle School  
38 School Street, Belmont, New Hampshire**

**Audit Date: December 16, 2009**

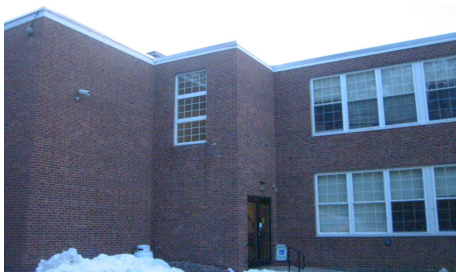
The 64,000 square foot building is mostly a metal framed structure with concrete block infill and red brick veneer. It is likely that the block is not insulated. It was originally constructed in 1936 with additions in 1960 and 1972. The building appears to be in less than average repair for a building of this age, condition, and use.

The roofs have metal trusses or wood rafters depending on the building section. They have wood, concrete, or tectum roof decking, depending on the area and construction year of the building. The roof covering is EPDM adhered rubber on the flat roof sections and asphalt shingles on the pitched roof.

ECM 30 – Tighten building envelope – The entire building envelope should be tightened. There are many areas of air infiltration and exfiltration. Completing this project will not only save energy, but increase the building comfort. We estimate an expenditure of \$5,000 will save \$1,568 annually. The payback based on these figures is 3.2 years.

ECM 31 – Add attic insulation – The attic space provides an easy opportunity to add insulation to the building. By doing so, air infiltration and exfiltration will be reduced, as well as occupant comfort levels. This project is expected to cost \$52,500, saving \$6,980 annually. The payback based on these figures is 7.5 years.

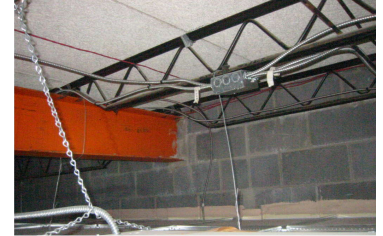
Observation of the foundation does indicate an opportunity to add insulation due to the proximity of exterior finishes and pavement. In new or modified construction it would be recommended to add protected rigid foam insulation around the exposed foundation perimeter and continue it below grade to control foundation and slab heat loss.

Generally, the building envelope is not “tight” in regards to air infiltration and out filtration. We observed many areas where the interface between in doors and out doors where day light could be observed and/or drafts could be felt. Examples are doors, windows, eaves, attic spaces, interstitial space between ceilings and floor deck above.

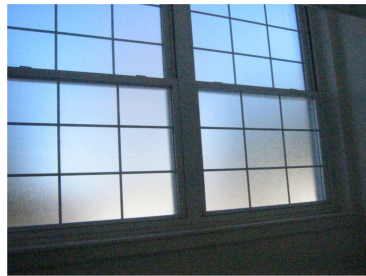
There are a total of twenty-seven exterior doors on this building. All but two are metal insulated. Sixteen of the doors are 1/2 –glass doors, two doors are full glass. The two remaining doors are metal un-insulated doors which are in poor condition. The rest of the doors are in fair condition; however, we recommend weather-stripping all the doors in the building annually to prevent infiltration/exfiltration of air.

ECM 28 – Replace exterior doors – Two of the doors have been rated in poor condition and should be replaced with newer, metal insulated doors. This measure will reduce heat loss due to loose fittings and lack of proper insulation. Total project cost is \$3,000. The savings once this project is complete is estimated to be \$300 annually, with a payback of 10 years.

ECM 32 – Door seals – We recommend replacing door weather-stripping and seals on a yearly basis, or at least as needed. New caulking and weather-stripping will reduce air infiltration and exfiltration, thus reducing energy spending. For this project, we recommend weather-strips on 27 doors for an estimated expenditure of \$2,700, and will save \$784 annually and payback in 3.4 years.

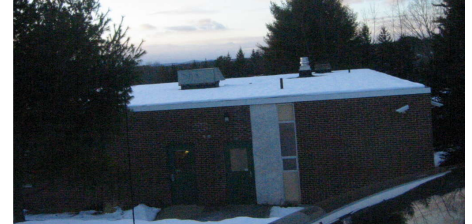
There are at least five roof top air handling units. A schedule of sizes and types was not readily available. Many, if not all areas of the building are served with fresh air from these units. The air is distributed via metal ductwork.

ECM 11 – Balance AHUs – The air handling units throughout the building are out of balance, thus providing unequal amounts of air to different areas of the building. We recommend balancing them to save on wasted energy, but to also increase the occupant comfort in the building. The estimated cost for this measure is \$4,500. Savings is approximately \$1,568 annually, with a payback of 2.9 years. This measure should be done in conjunction with other AHU projects and the DDC controls.

ECM 14 – Install VFDs on AHUs – The air handling system runs at a constant speed. By installing variable speed drives to the air handling units, there will be more control over air flow. This will allow air to move less frequently and only as needed to specific areas, thus cutting back on the run time of equipment. We are recommending five VFDs. The estimated cost for this measure is \$10,000, with an annual savings of \$2,750. We estimate a project payback of 3.6 years.
