*SAU 80 – Shaker Regional School District  
Canterbury Elementary School*

***Energy Audit Report***

#### **SAU 80 Canterbury Elementary School 15 Baptist Road, Canterbury, New Hampshire**

**Audit Date: December 17, 2009**

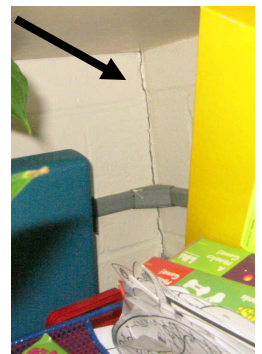
The roofs are flat with a metal superstructure, rubber membrane covering, and foam insulation.

Observation of the foundation does not indicate an opportunity to add insulation due to the proximity of exterior finishes and landscaping.

ECM 24 – Add insulation – There is very little insulation above the ceiling of the building, and due to the ceiling type, more insulation can easily be added. We recommend adding insulation to the roof deck or the ceiling throughout the building for added comfort and to lower energy costs. The projected expenditure for this project is \$15,000. Annual savings is approximately \$3,000, for a payback of 5 years.

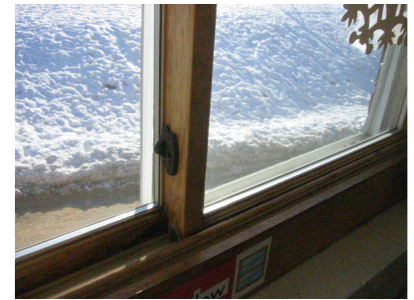
There are a total of eighty-one windows in the building. Forty-five of them are double-pane, wood framed windows, which are extremely drafty and should be replaced. There are also thirty-three double-pane, wood framed windows that are part of the double-hung window system and most should be replaced to reduced draftiness. The remaining windows are skylights. In the library, under the skylights and vaulted ceiling, cold drafts could be felt at the floor level. This is due to poor insulating value of the skylights, little or no insulation in the vaulted ceiling area, and the large round picture window lacking an insulating curtain.

ECM 21 – Replace exterior windows – Almost all of the windows were observed to be very drafty, causing air infiltration/ex-filtration, as well as occupant discomfort. We recommend replacing the exterior windows in the building. The cost of this project is \$70,000 and will save \$2,540 annually, as well as increase comfort within the building. The payback based on these figures is 27.6 years.

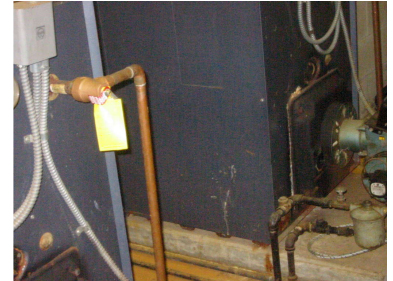
The two older building sections are heated by a single Burnham hot water boiler model V909 nine section boiler. The boiler is rated at 1.054 MMBTU, with a firing rate of 9.1 GPH. It has a Carlin burner model 702CRD with a firing rate capacity of 6-13 GPH. It burns #2 fuel and has no fuel pre-heaters.

There are four 1-horsepower, 144 gallon per minute, single speed circulator pumps running 24/7/365. There are two ½-horsepower, 114 gallon per minute, single speed circulator pumps running 24/7/365.

ECM 13 – VFD circulator pumps – We recommend replacing the single speed motors with variable speed drives and motors for the heating hot water circulation loops. The project cost is estimated at \$8,000, with an annual savings of approximately \$1,200. Based on the savings, this project will payback in 6.7 years.

ECM 14 – Wood-pellet boiler – The existing boilers were installed in 1990 making them 20 years old. We are recommending installing a wood-pellet boiler system in the school for better heating and lowered heating costs. The cost for this project is \$155,000, with an annual savings of \$12,000 and a payback of just under 13 years. Furthermore, dependence on foreign oil and the unpredictable prices that accompany it could be avoided.
